**MOUNTCASTLE KNITTING COMPANY/DIXIE FURNITURE COMPANY SHOWROOM-
OFFICES (URS survey #7A)
South side of South Salisbury Street between East 4th Avenue and East 5th Avenue**

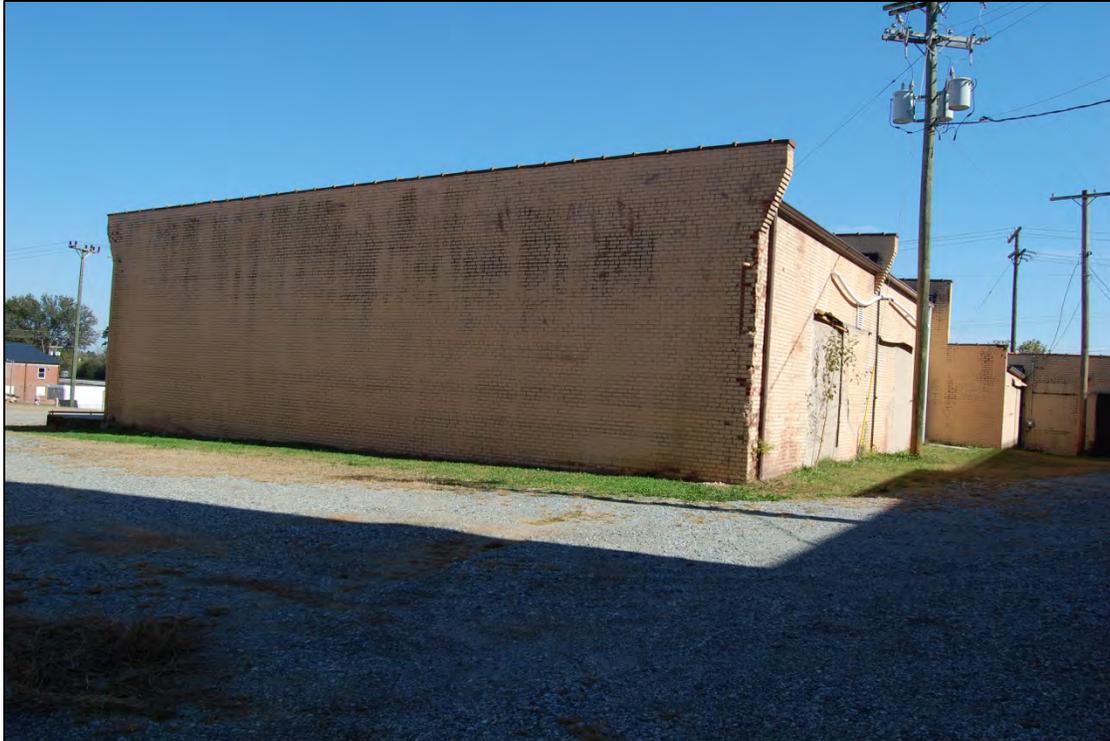
Figure 39: Southeast corner of cotton warehouses complex (ca.1896-1902); note parapet firewalls

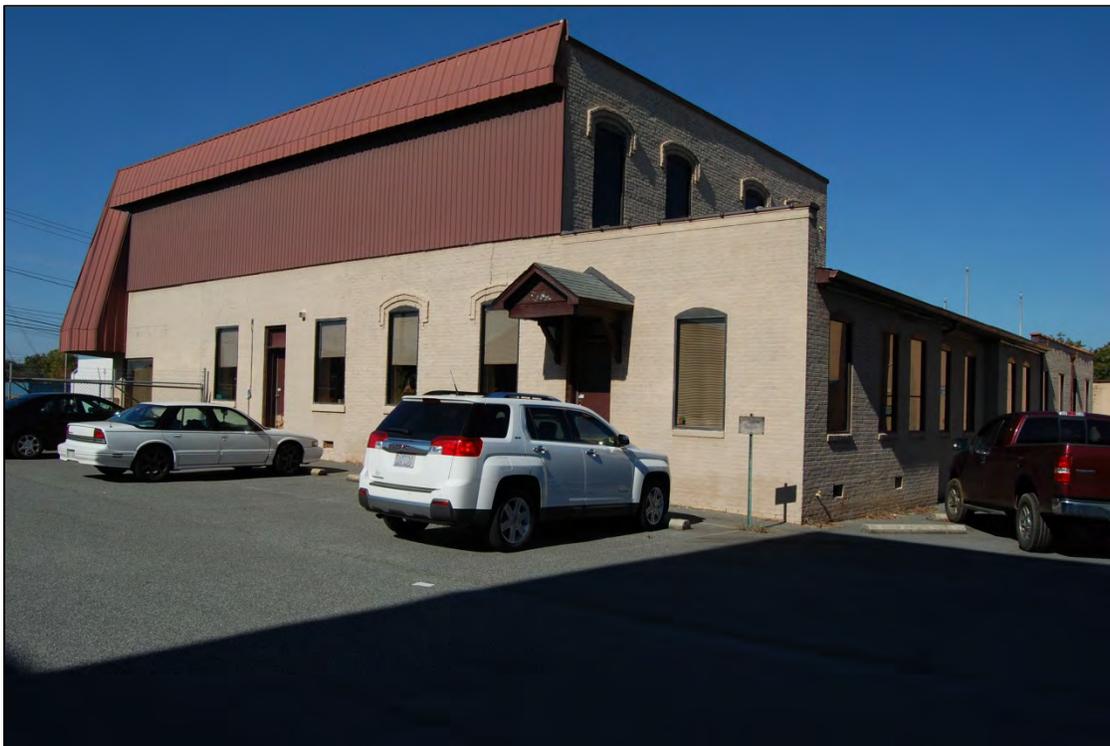
Figure 40: Southwest corner of office building (ca.1886-1896 with later additions)

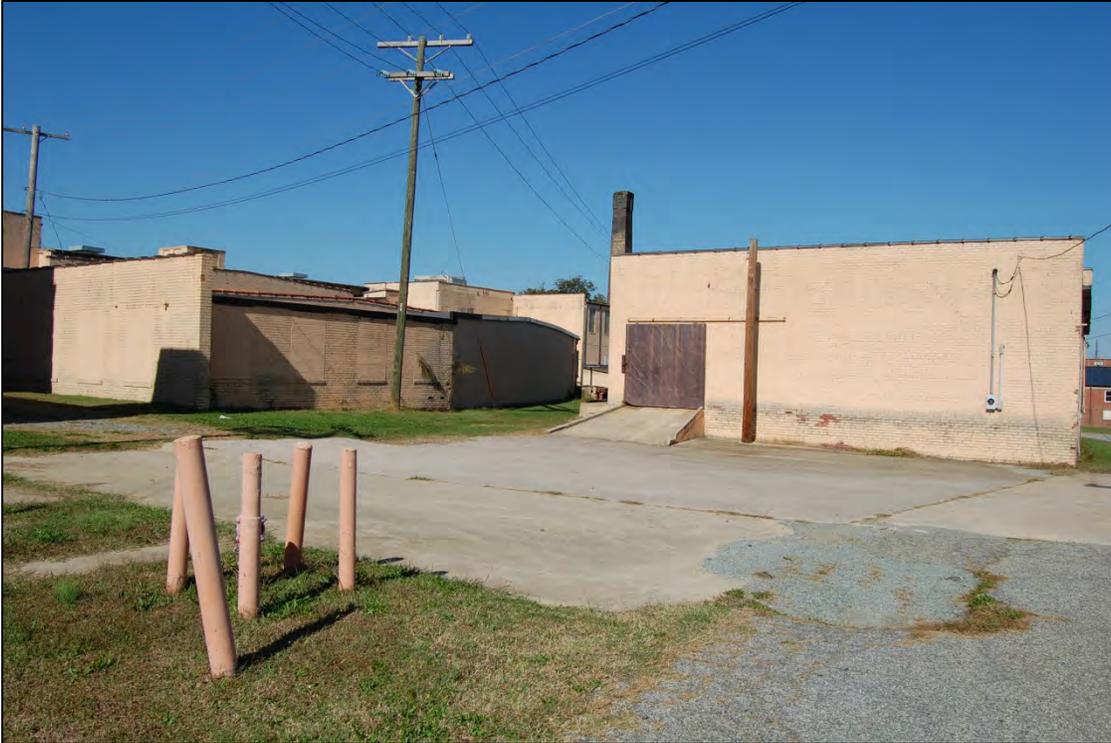
Figure 43: East side of cotton warehouse (ca.1886-1896) at right with opening room (ca.1929-1948) portion of cotton warehouse complex at left; the track of a spur line once ran between them

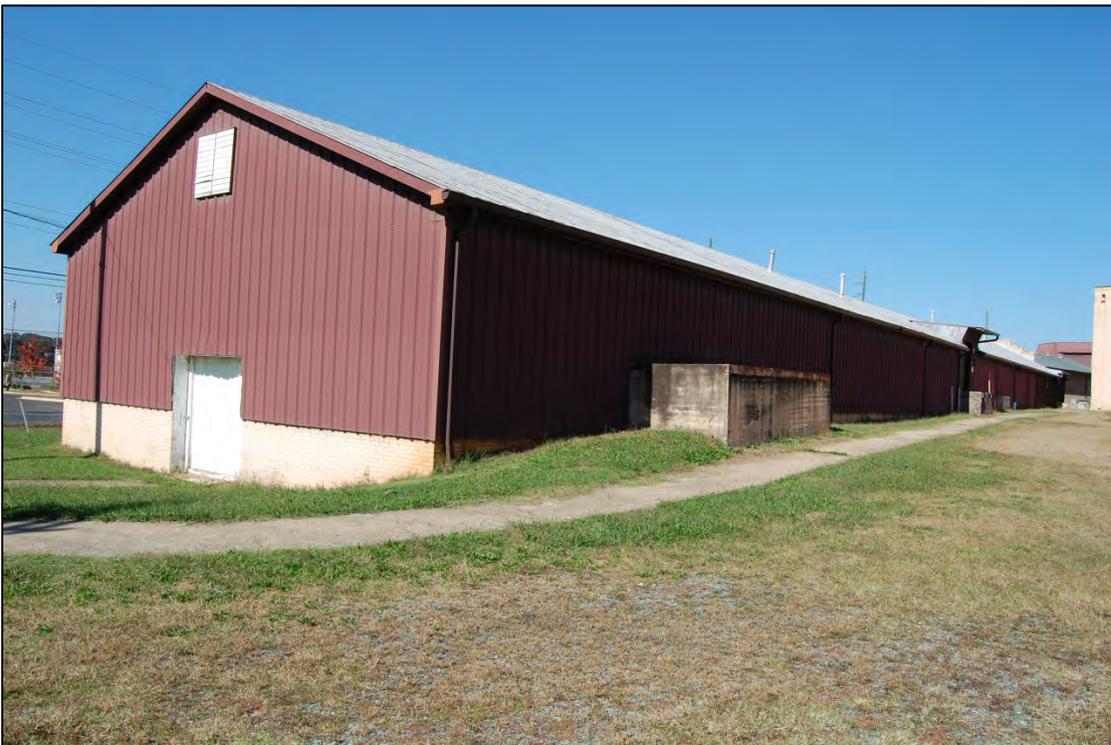
Figure 44: West side and long south elevation; of stockroom (ca.1929-1948 and later)

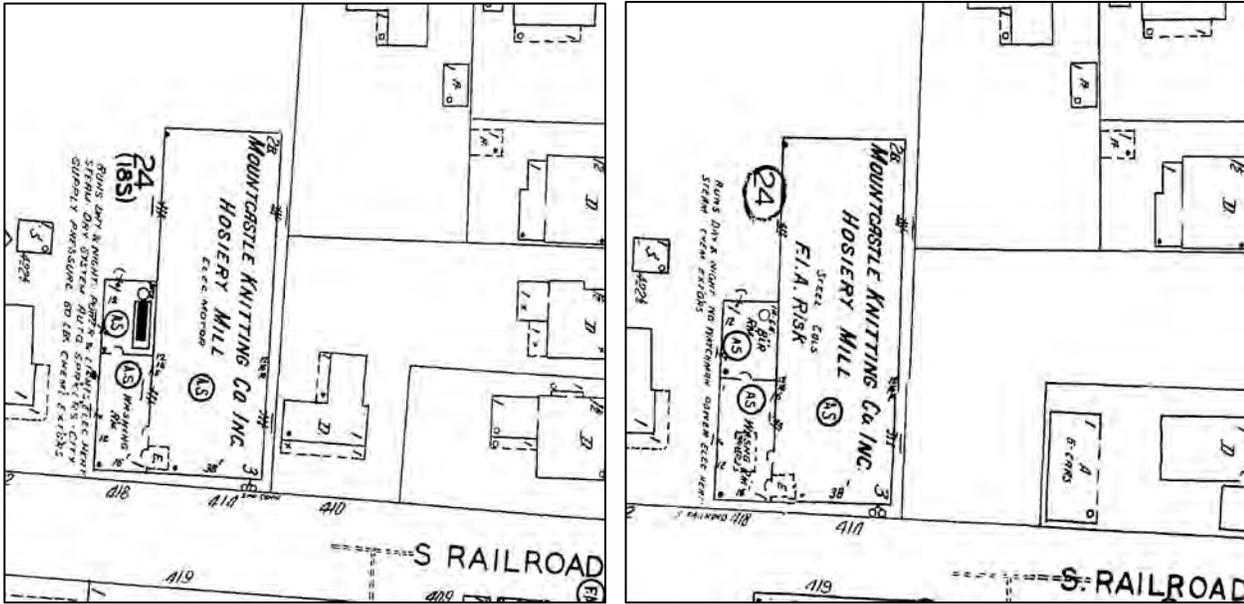
Figure 46: Mountcastle Knitting Mill, 1929 Sanborn map, at left, and map updated through 1948, at right, depicting virtually no changes to the building

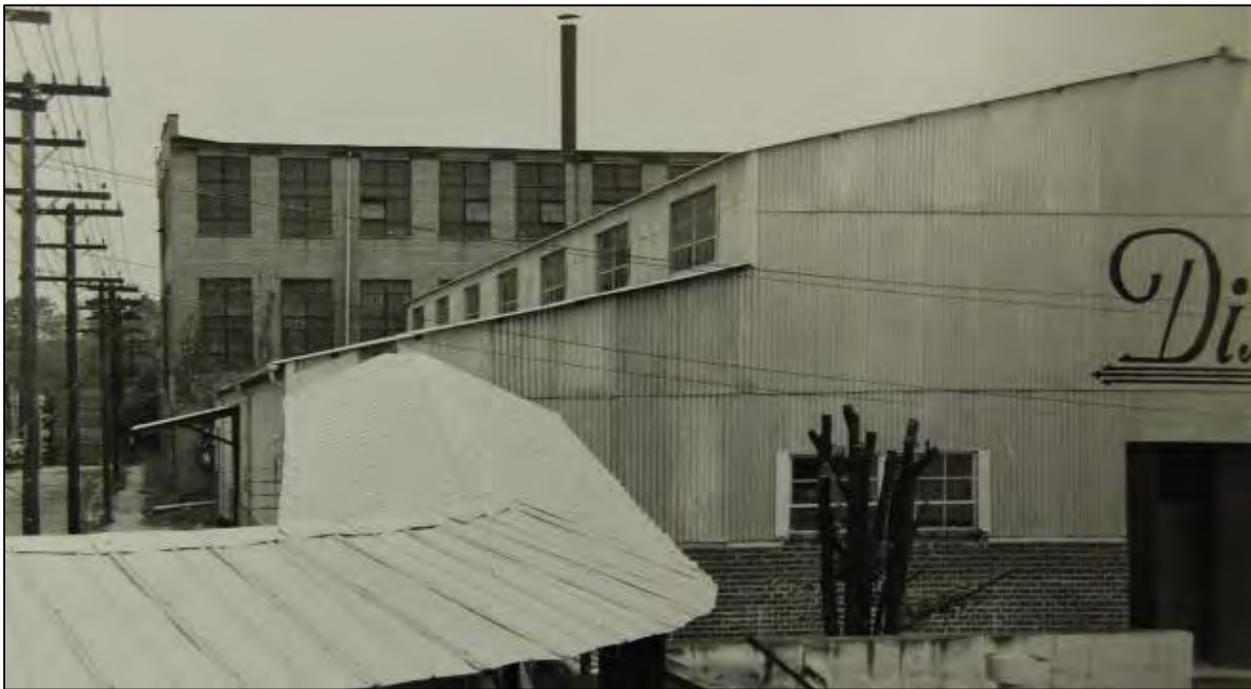
Figure 47: East side elevation of Mountcastle mill building, at left rear, displaying generous windows, ca.1950 (source: Davidson County Historical Museum, H. Lee Waters collection 96.11339)

Because of its office and showroom function, the building retained its windows during the 1950s and continues to display long multi-light sash on both side elevations and at the rear. It also retains its basic rectangular, four-story shape, masonry structural frame, brick-veneered walls, and slightly peaked, gable-front roof. The original two-story wing at its southwest corner, however, had an additional two stories added to it, likely in the mid-50s, which are not lit by windows.

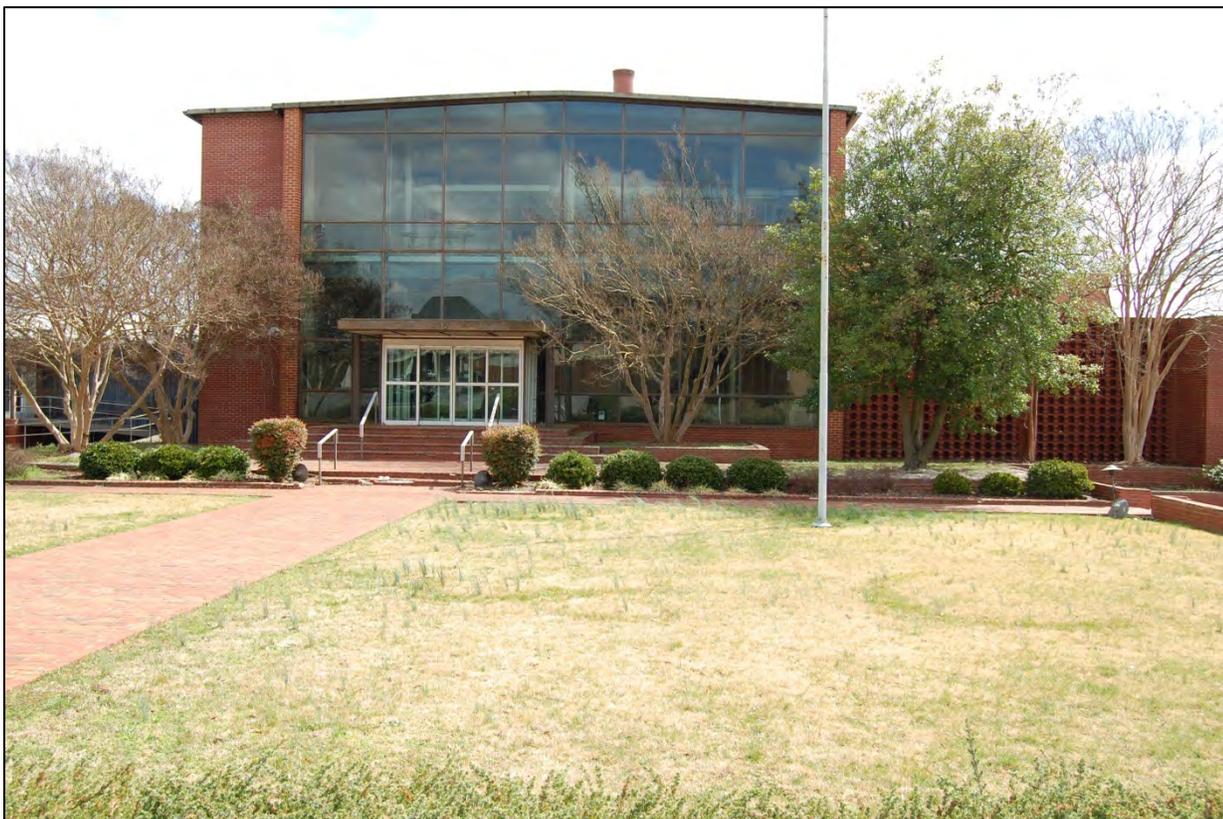
Figure 49: North-facing mid-century Modernist façade with contemporary landscaping

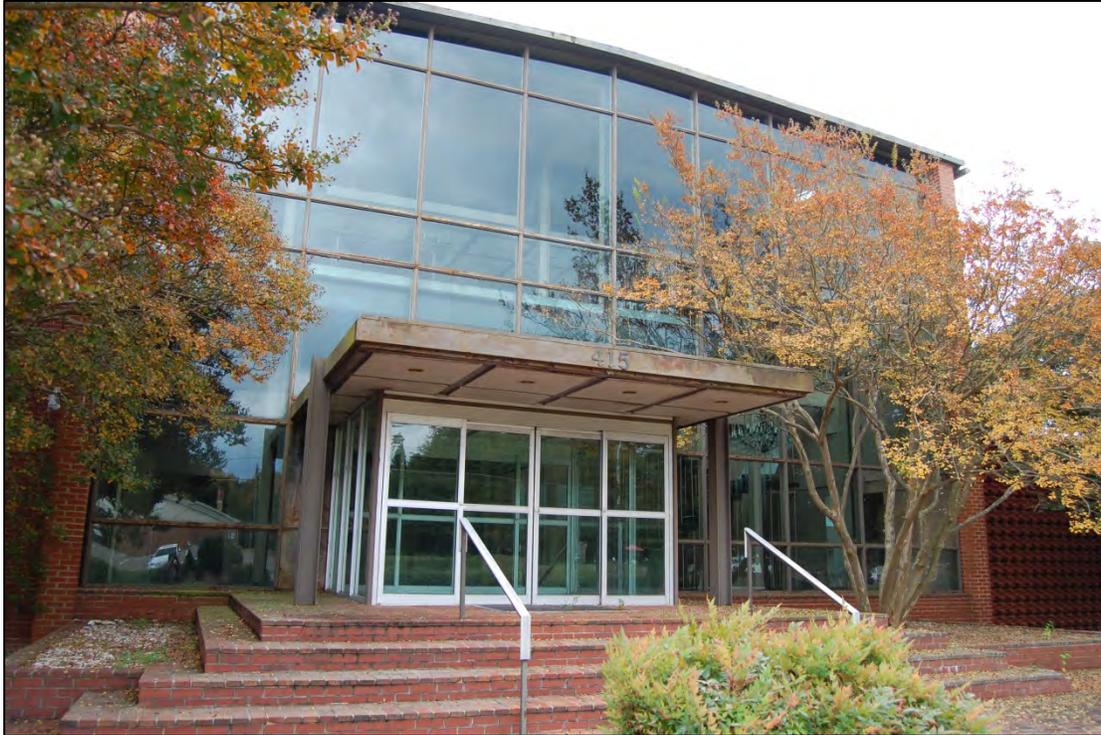
Figure 50: Detail of north-facing Modernist façade

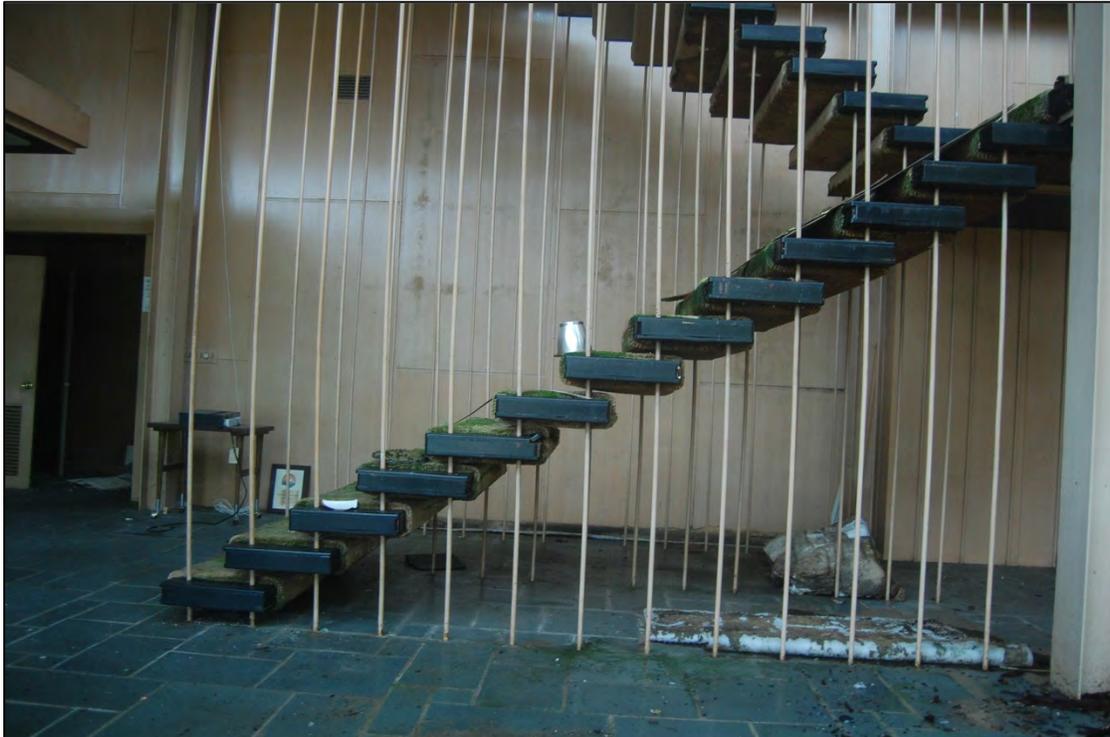
Figure 51: Floating stair behind Modernist façade

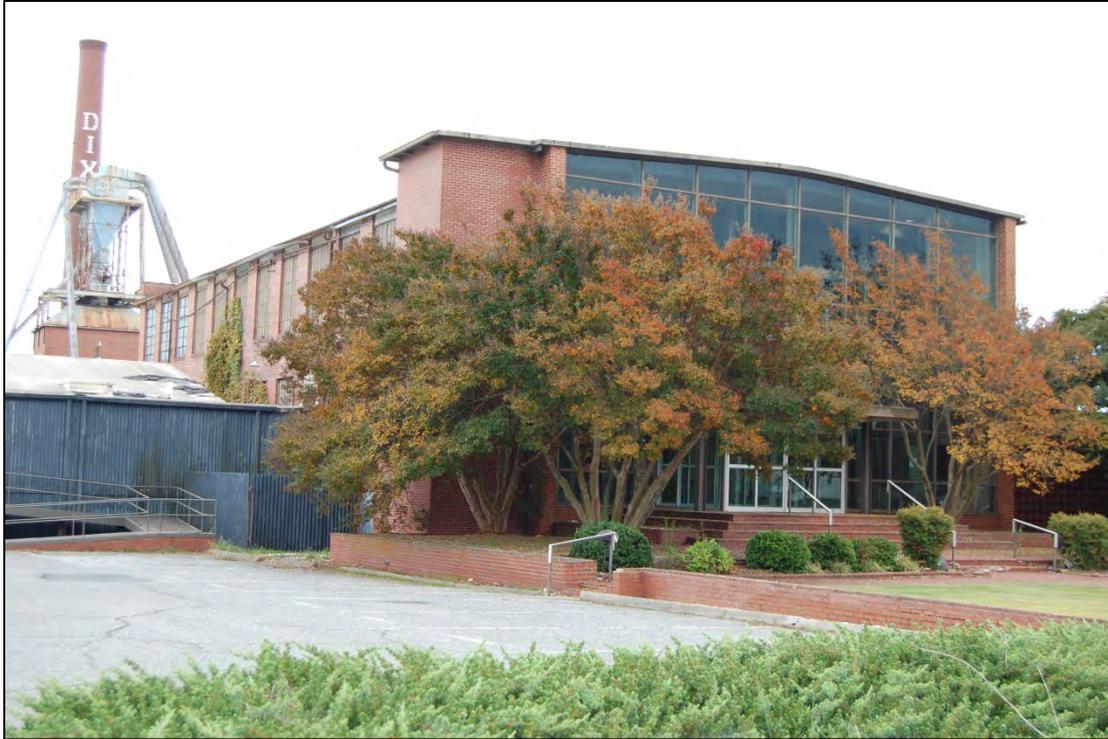
Figure 52: North front façade and east side elevation retaining intact windows

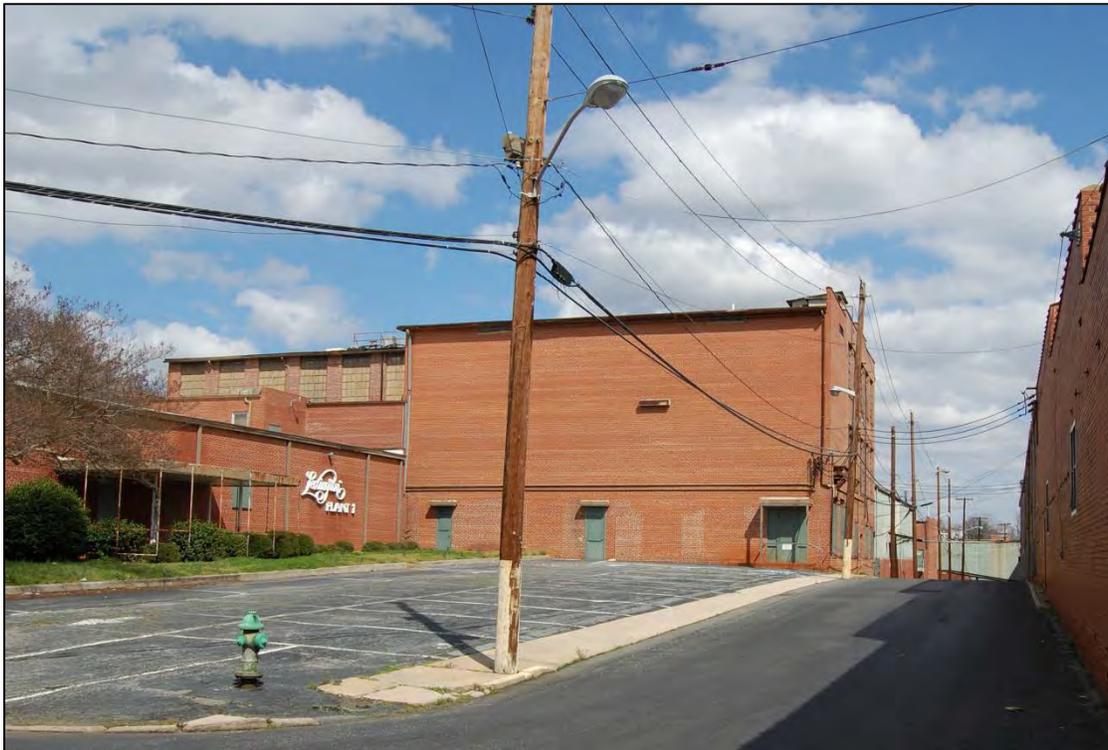
Figure 53: South elevation along Railroad Avenue and west side elevation with intact windows at left and windowless two-story addition at right

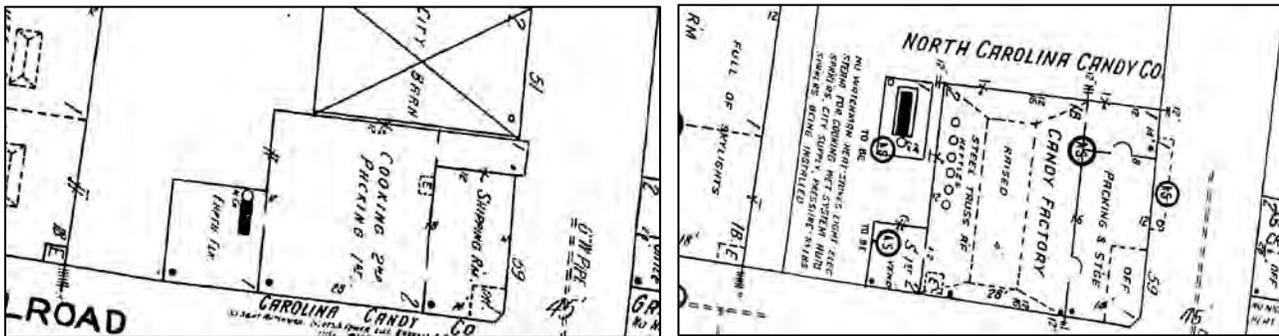
Figure 56: 1923 Sanborn map at left and 1929 map at right; newspaper accounts, partitions, and physical evidence indicate that the company retained much of the east, south, and west walls following the 1928 fire

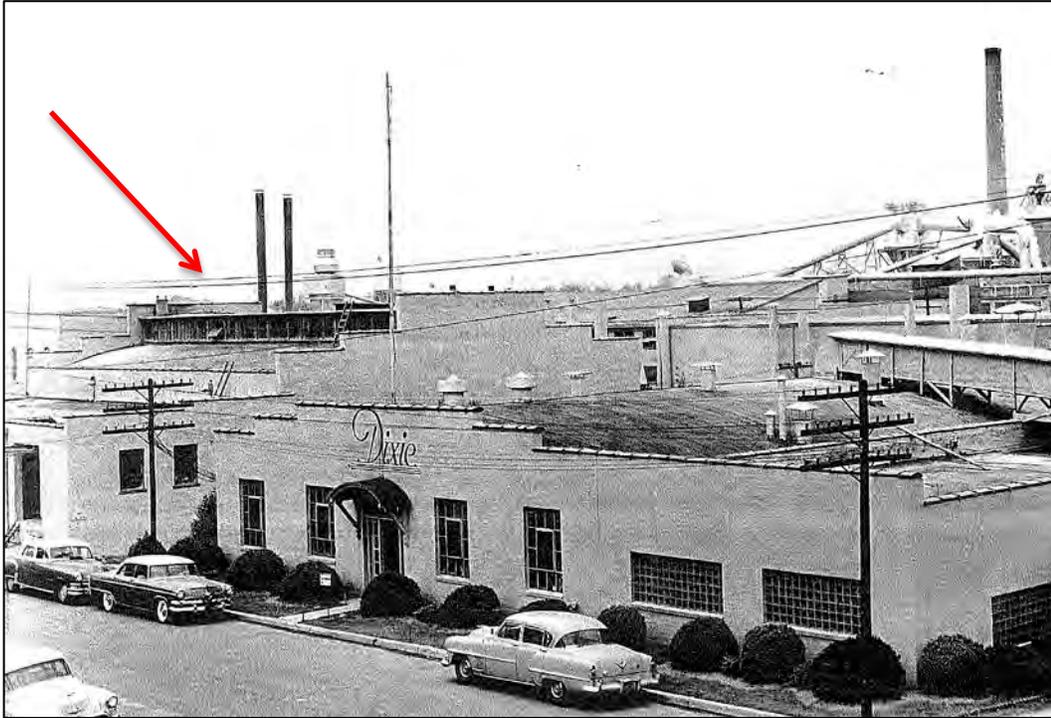
Figure 60: Clerestory window atop former North Carolina Candy Company building at center left (red arrow) with stacks of Elk/United Furniture Company immediately behind, ca. mid-1950s (source: Davidson County Historical Museum, image P 01.58.3a)

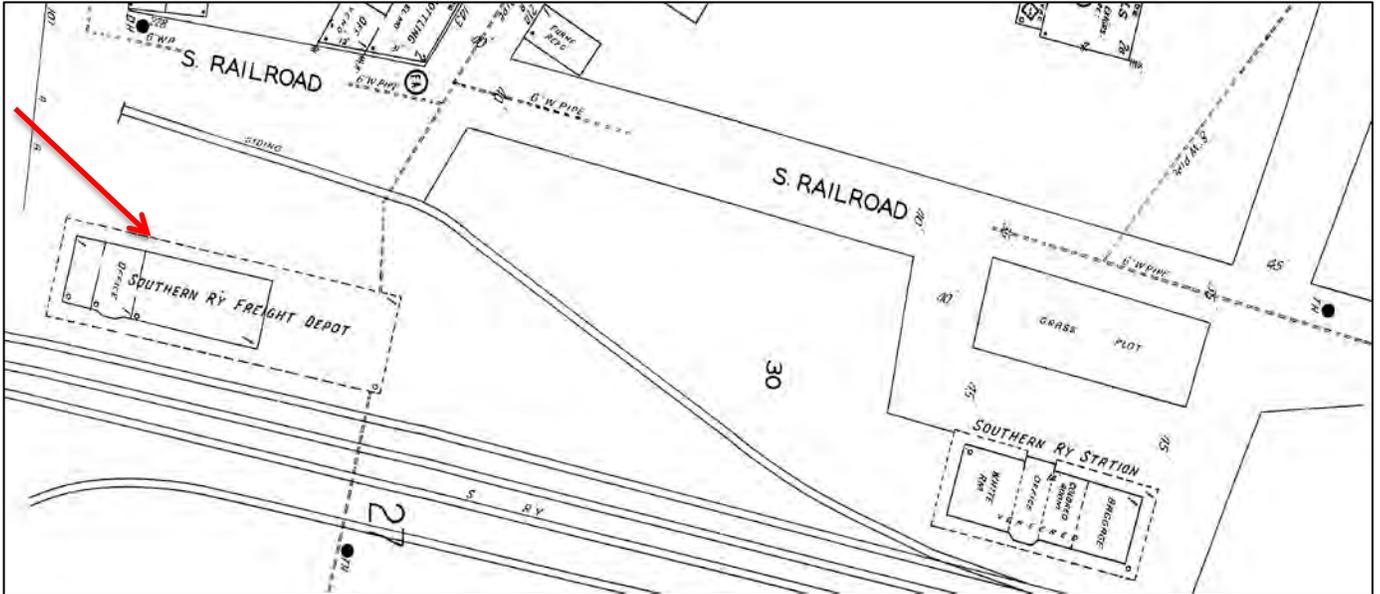
Figure 67: 1929 Sanborn map; note location of previous depot at red arrow

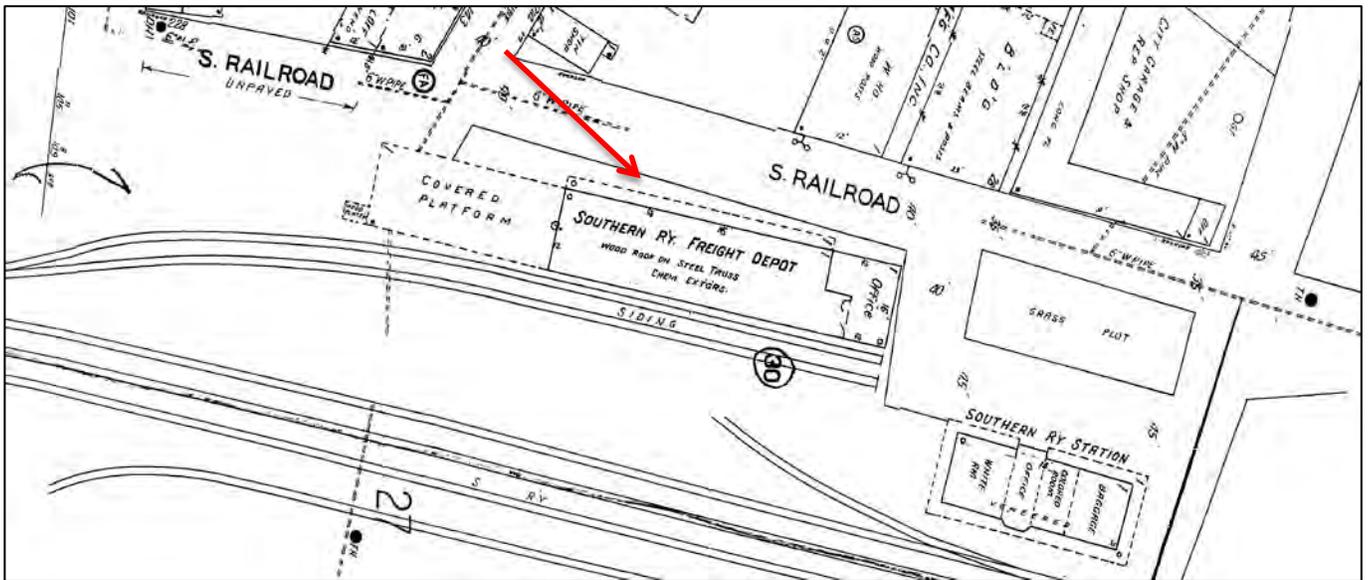
Figure 68: 1929 Sanborn map updated through 1948 with location of current depot at red arrow; note removal of previous depot and that the Southern Railway Station at the lower right (southeast) is also no longer extant

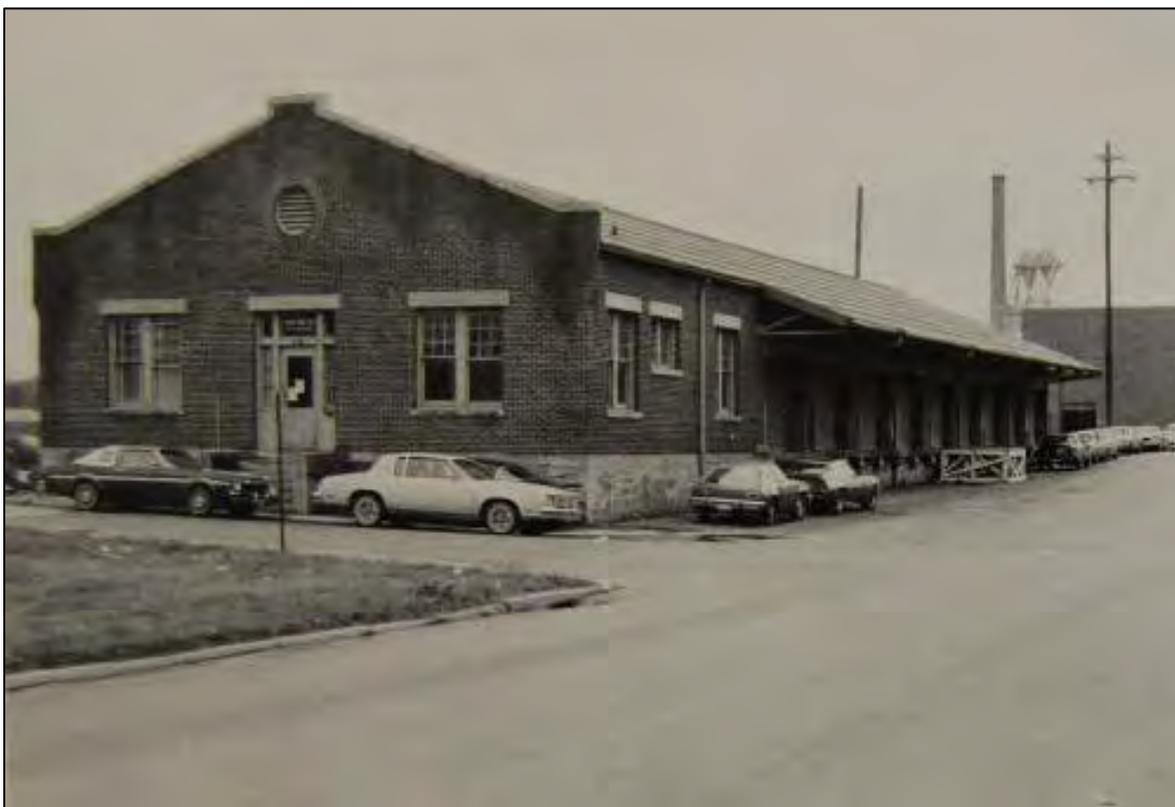
Figure 70: Lexington Southern Railway Freight Depot, east office end and south office windows and freight bays in 1987 (source: Touart, *Building the Backcountry*)

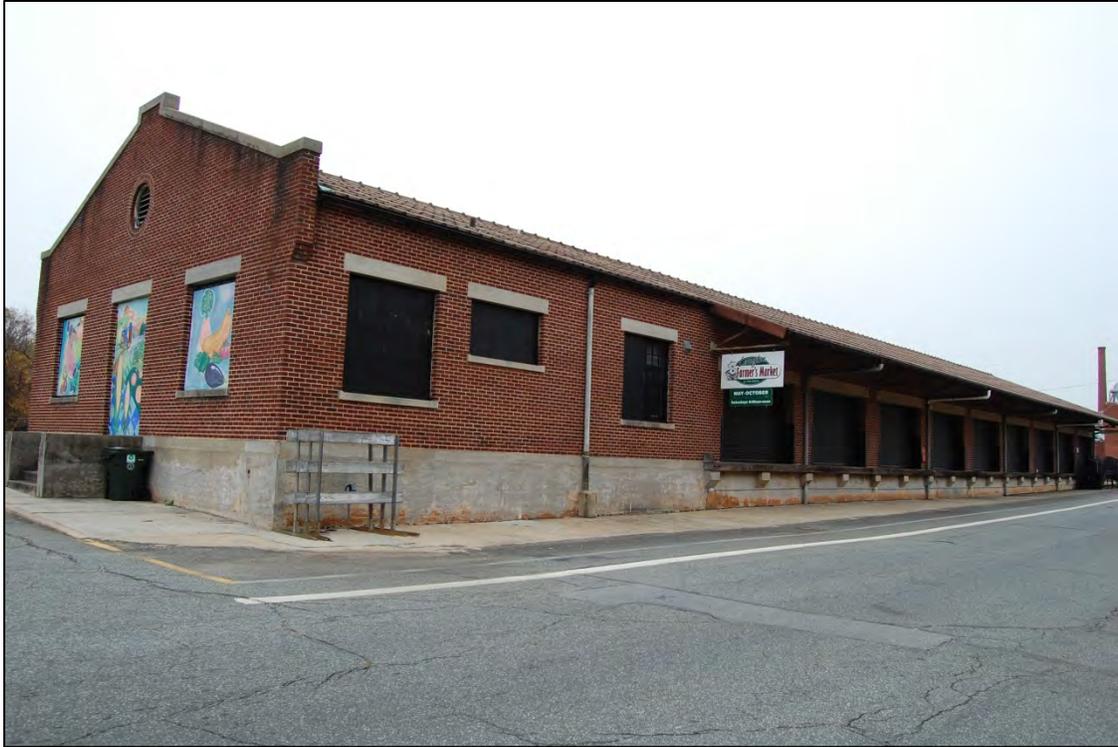
Figure 71: Lexington Southern Railway Freight Depot, east end and north side elevations

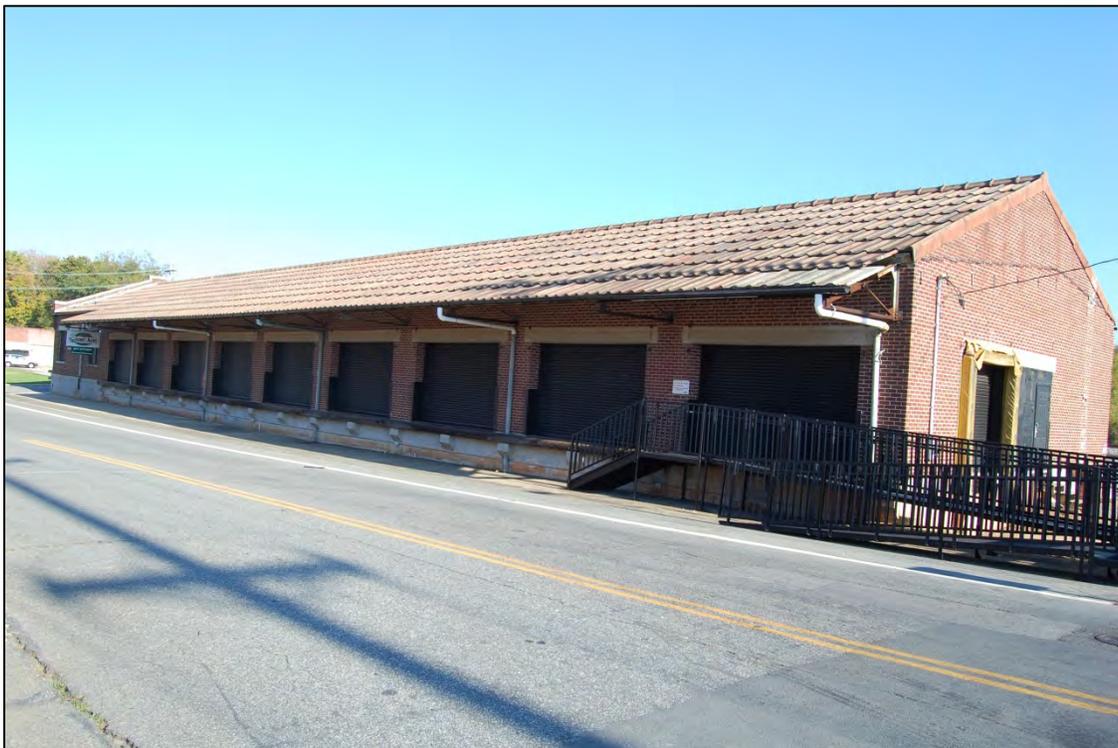
Figure 72: Lexington Southern Railway Freight Depot, north side and west end elevations

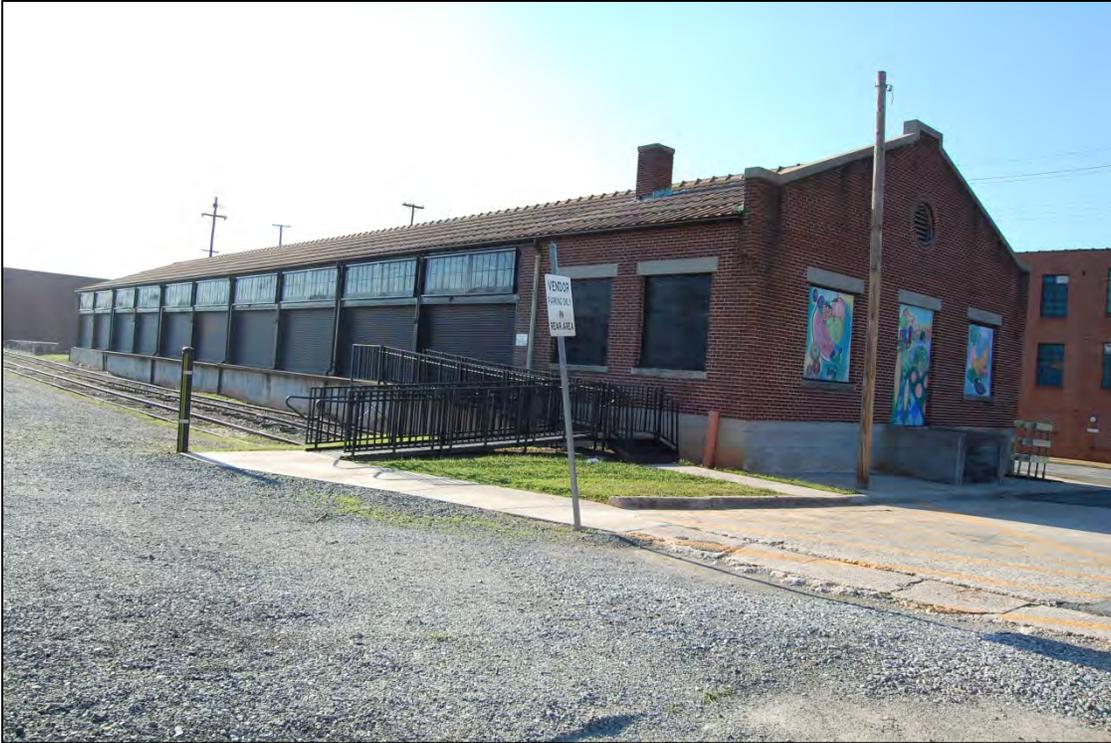
Figure 73: Lexington Southern Railway Freight Depot, east end and south side elevations

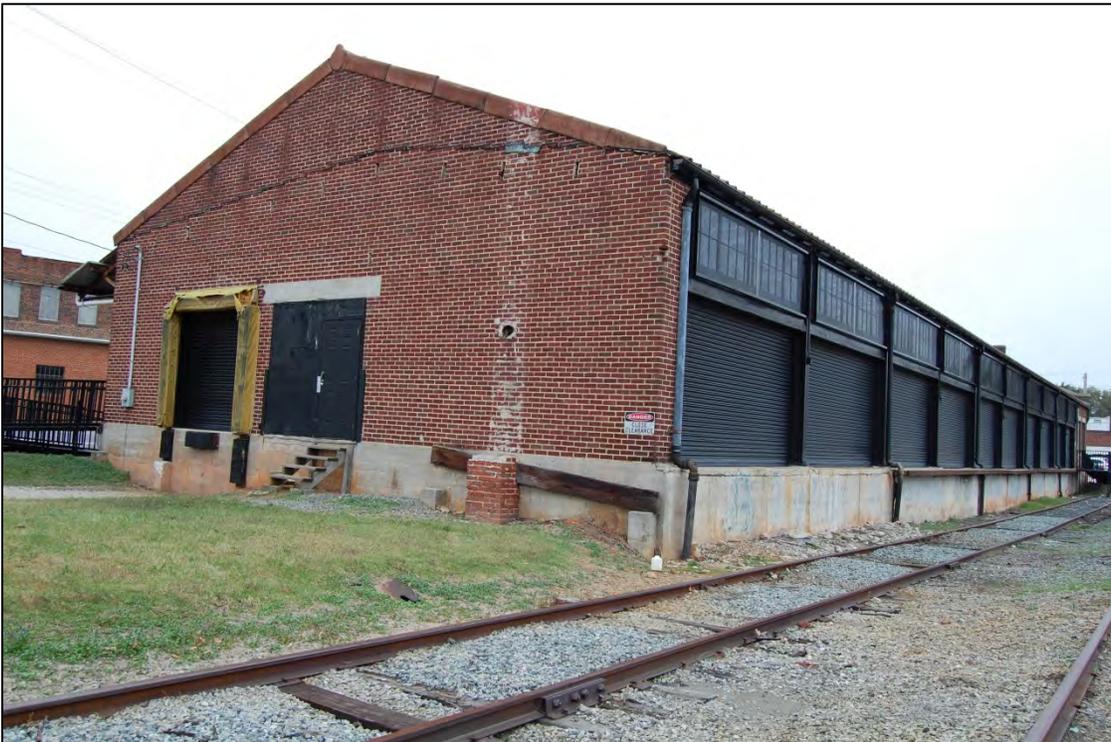
Figure 74: Lexington Southern Railway Freight Depot, west end and north side elevations with two spur lines in foreground

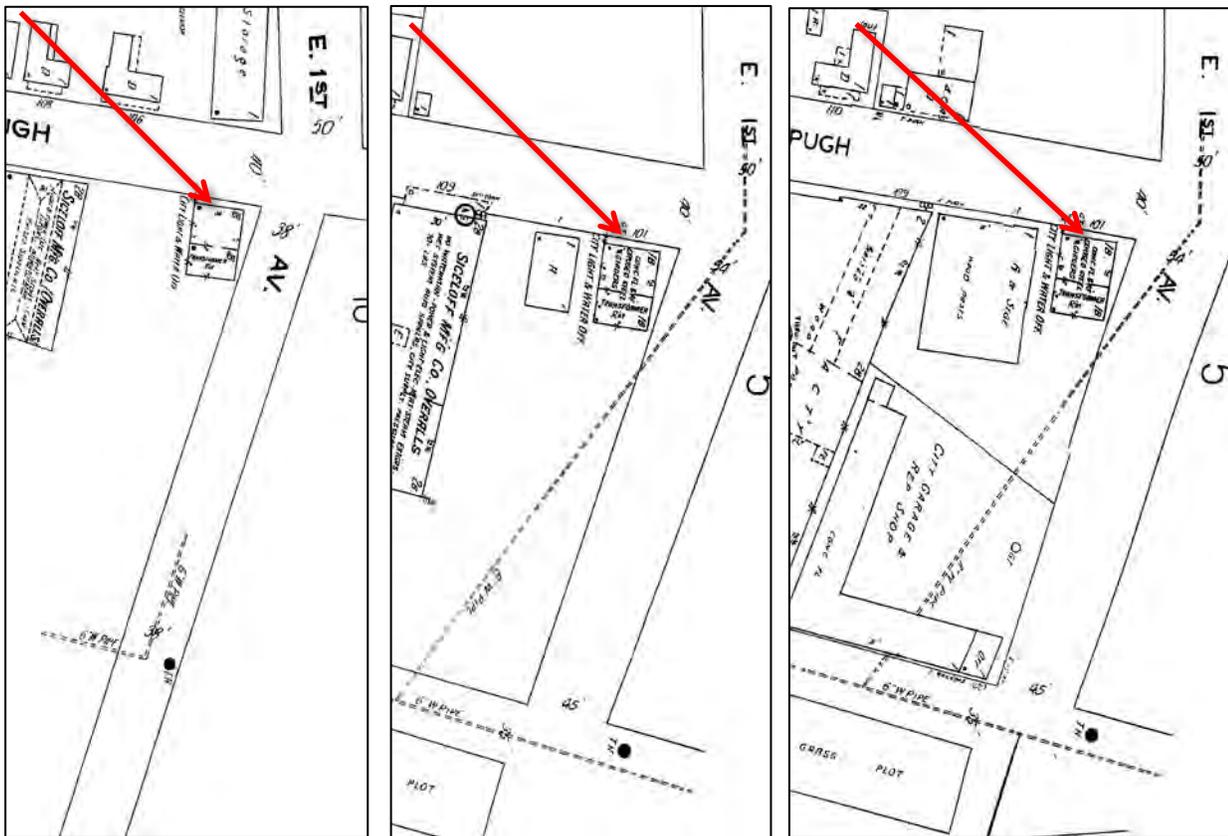
Figure 77: City Light and Water Offices building denoted by red arrows on Sanborn maps of 1923 at left, 1929 at center, and 1948 at right

The 1929 Sanborn notes that the rear (southern) section of the City Light and Water Office building held a transformer room. Although water storage, filtering, and pumping had been shifted out of town, power generation had remained behind. The 1929 map depicts a garage to the building’s west and the 1948 update shows an even larger automobile and storage building on the site of that garage. That associated building was subsequently replaced by a smaller building affixed to the main building, perhaps in 1950, the date assigned to the complex in tax records. The 1948 map also depicts a city garage and repair shop to the south, the property of which is still part of the light and water building parcel and owned by the city. To its south, a “grass plot” had taken over the site of the earlier pumping station and power plant. Lexington still owns the City Light and Water Office building and maintains offices for its water resources division there.

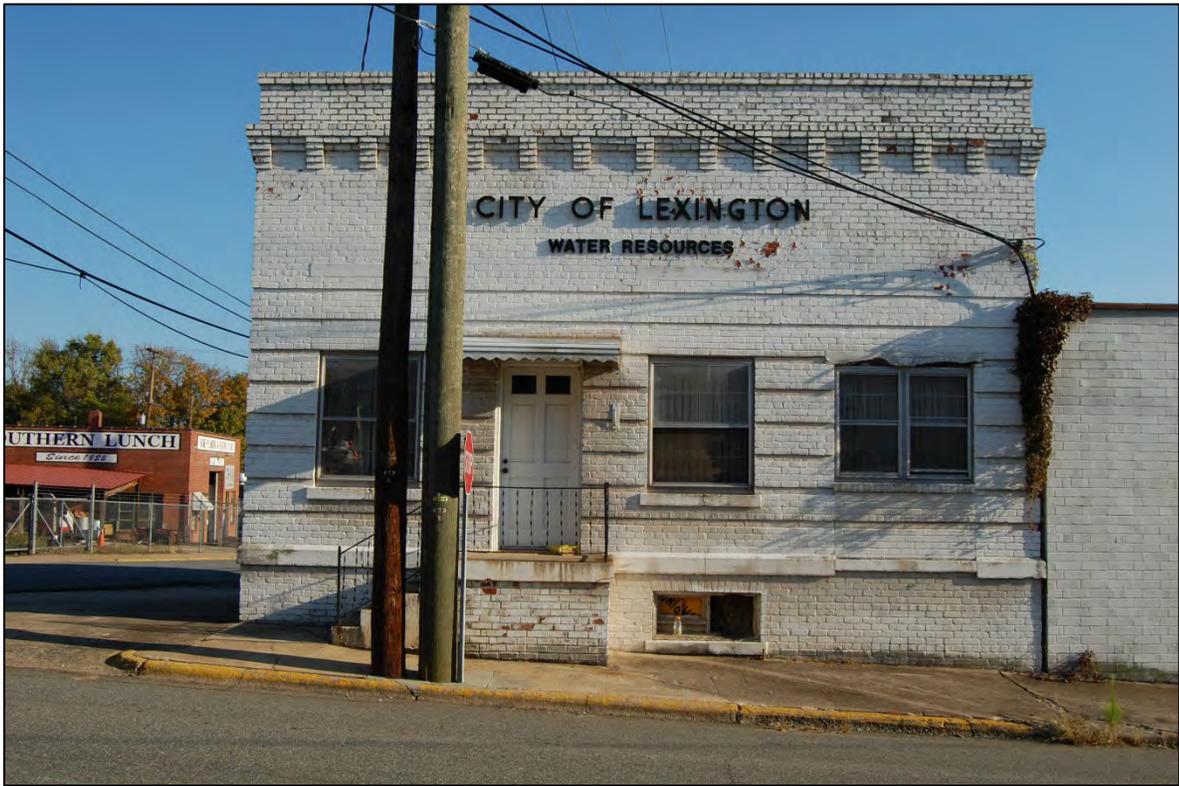
Figure 79: North front elevation of Lexington City Light and Water Office

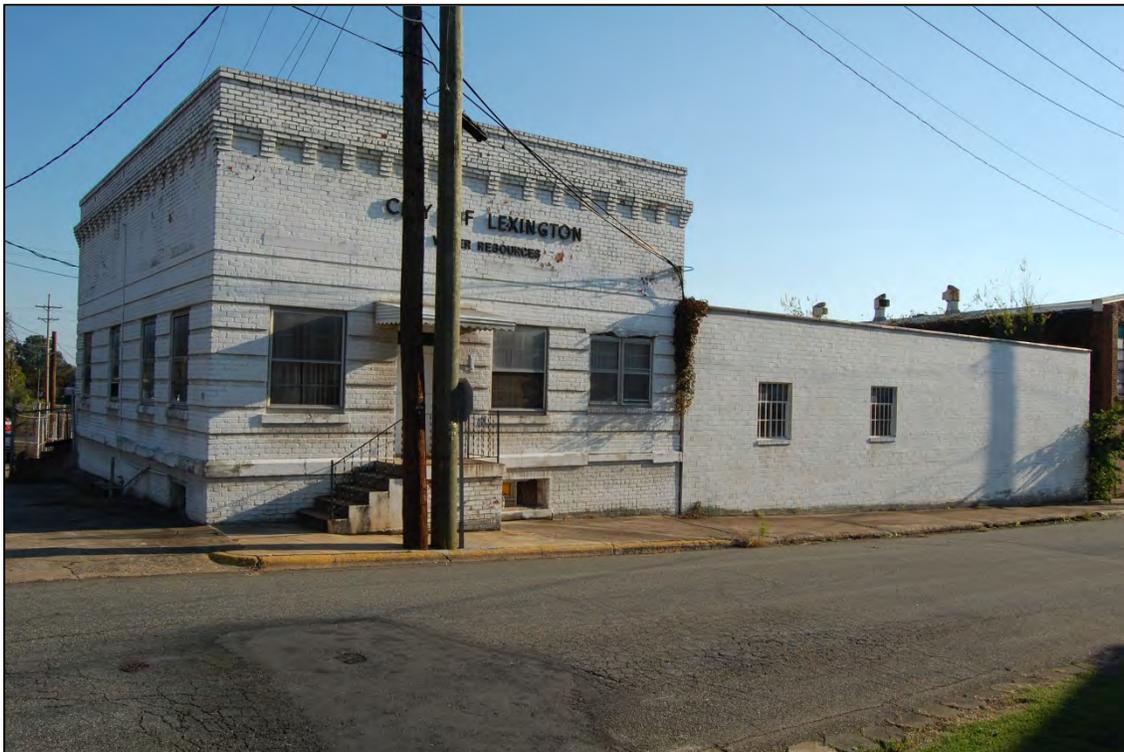
Figure 81: North front and east side elevation of Lexington City Light and Water Office; ca.1950 service building at right

brickwork of the bands and the cornice was maintained through any alterations. As already noted, the lower, flat-roofed, one-story, brick wing to the main block's west is a later addition, possibly dating to about 1950.

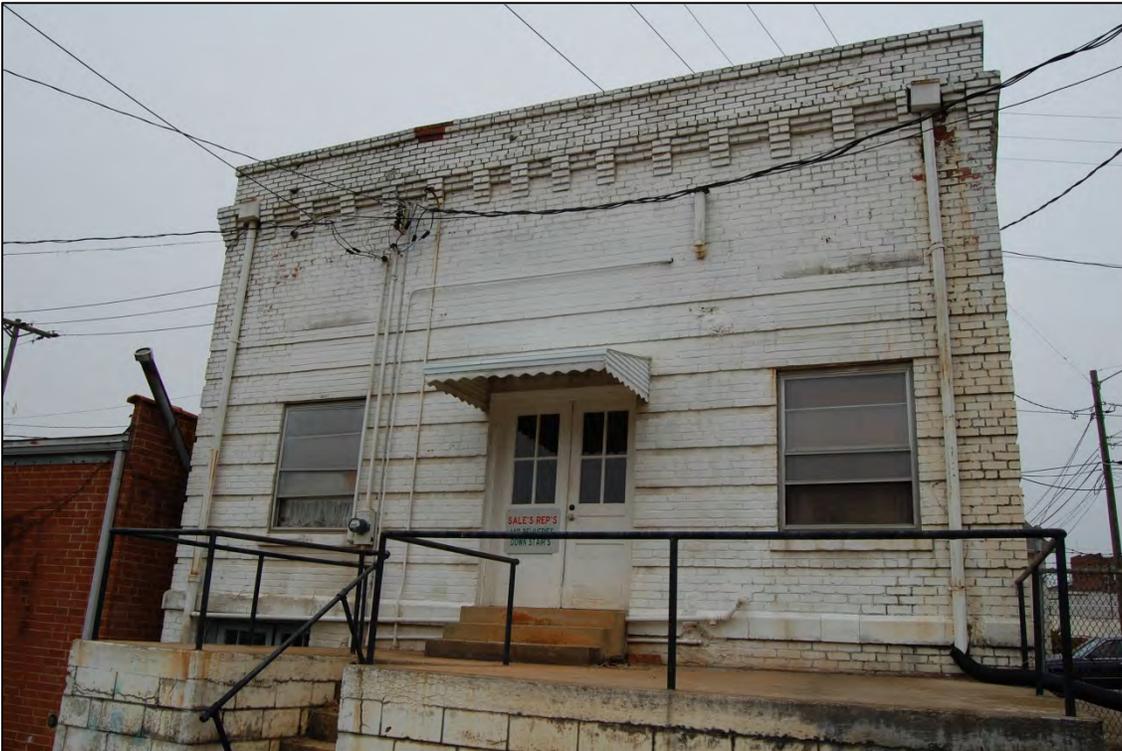
Figure 83: South rear elevation of Lexington City Light and Water Office

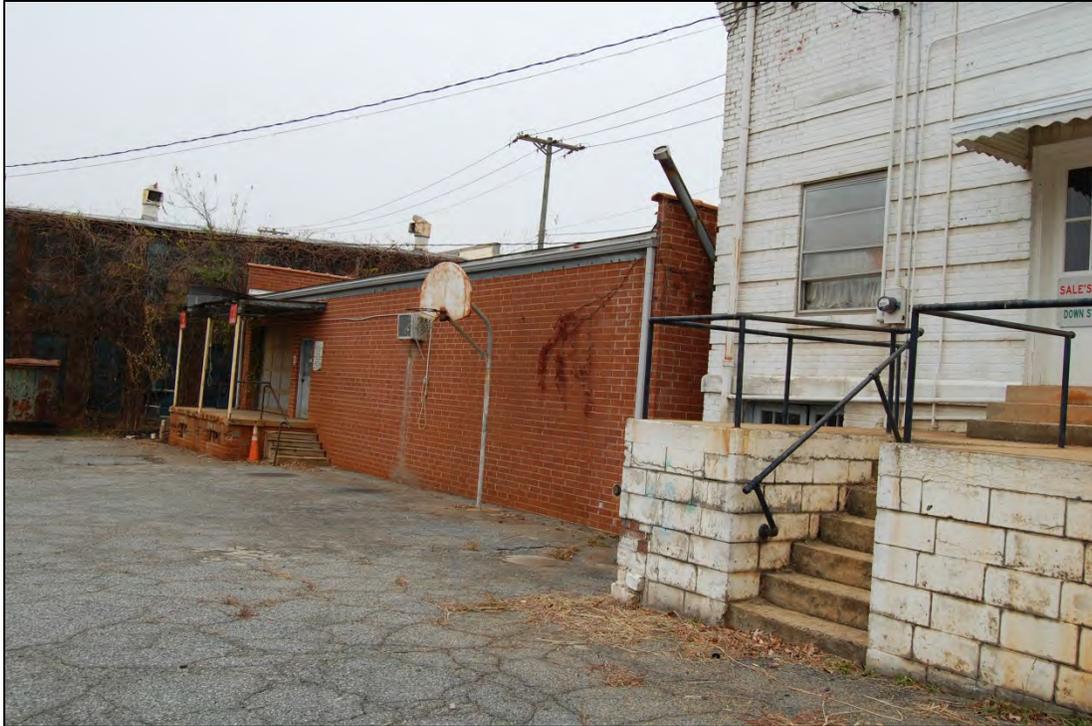
Figure 84: South rear elevation of Lexington City Light and Water Office with detail of rear platform and, at left, rear of service building

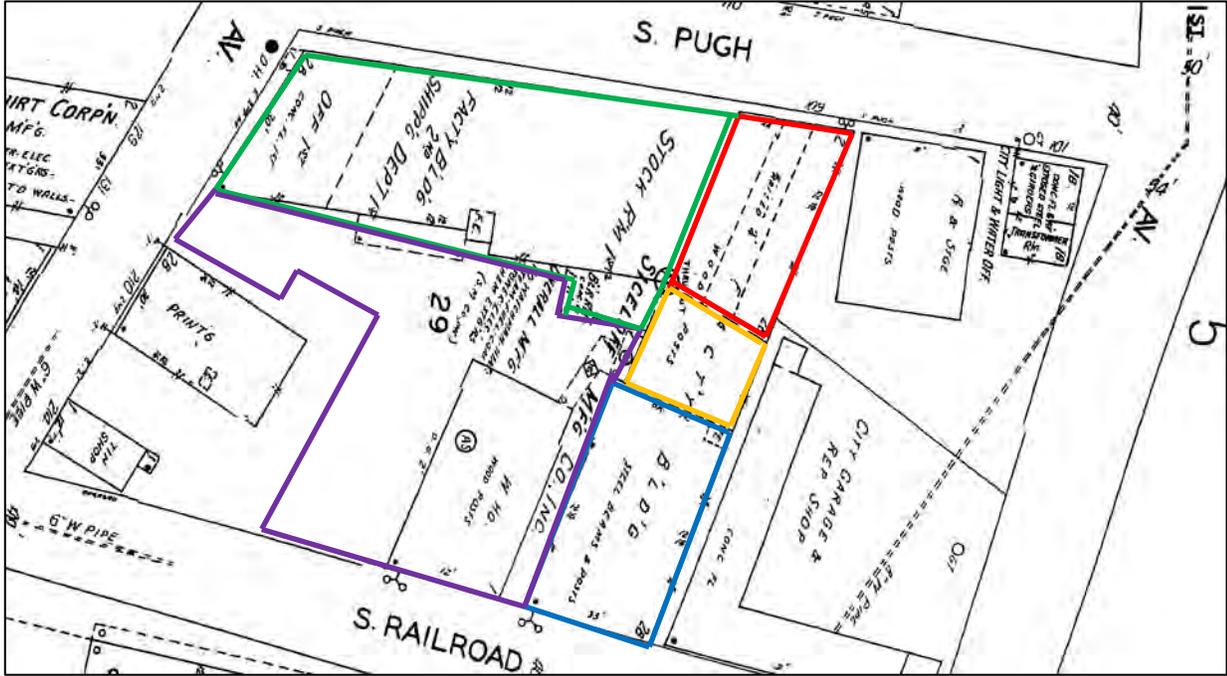
Figure 88: Updated 1948 Sanborn map: original factory (1915) marked in red; early addition (ca.1923-1929) marked in orange; 1939 building marked in blue; building erected ca.1946-1948 marked in green; and ca.1954 build-out marked in purple
