**MOUNTCASTLE KNITTING COMPANY/DIXIE FURNITURE COMPANY SHOWROOM-
OFFICES (URS survey #7A)
South side of South Salisbury Street between East 4th Avenue and East 5th Avenue**

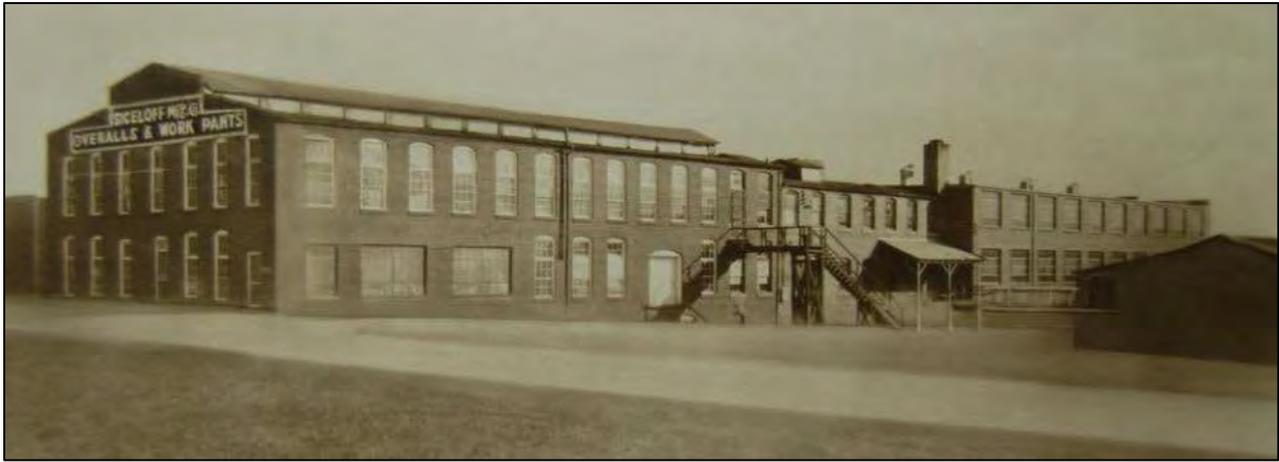
Figure 92: Siceloff Manufacturing Company, ca.1939 photograph with original factory building at left, 1920s addition at center, and 1939 addition at right; no-longer-extant one-story frame warehouse at far right (source: Davidson County Historical Museum, H. Lee Waters collection 96.1912)

About 1954 the complex received one final and extensive build-out. A one-story frame warehouse depicted on the 1948 map and in the historic photograph (Figure 92) was replaced by a two-story brick building with a much larger frontage on Railroad Street (Figure 101 - Figure 103). A photograph from the 1950s captures the build-out on Railroad Street, probably not long after its completion (Figure 102). Additions were also made to the south side of the long Pugh Street addition (Figure 100). These additions were, again, functional, two-story, brick buildings lit by expansive casement windows. Only one historic interior photograph of the factory has been identified (Figure 104). Taken in 1954, it depicts women sewing in a large open space supported by wooden or steel posts (*Lexington Dispatch*, November 11, 1955). It was likely taken in the long factory building that extends between Pugh and Railroad Streets.

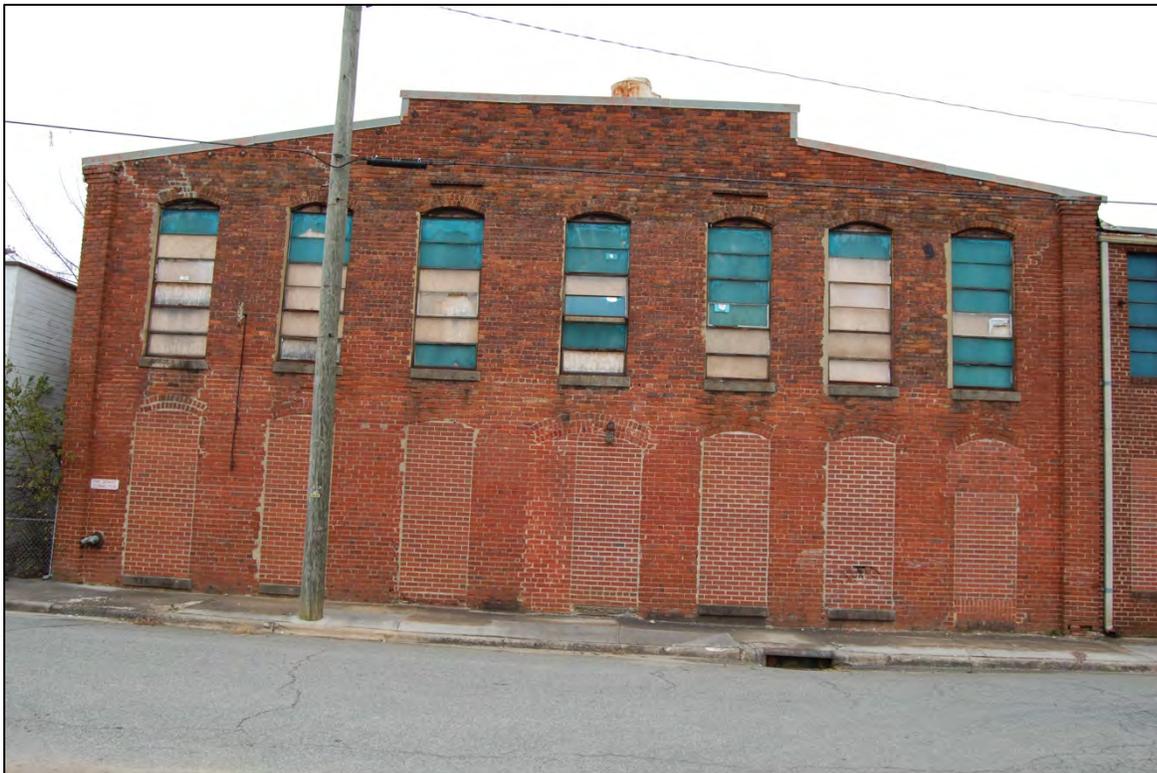
Figure 93: Siceloff Manufacturing Company, north front (Pugh Street) elevation of original factory building; note retention of arches and pilasters, but filled bays, replacement sash, and altered brickwork at parapet, likely due to removal of clerestory

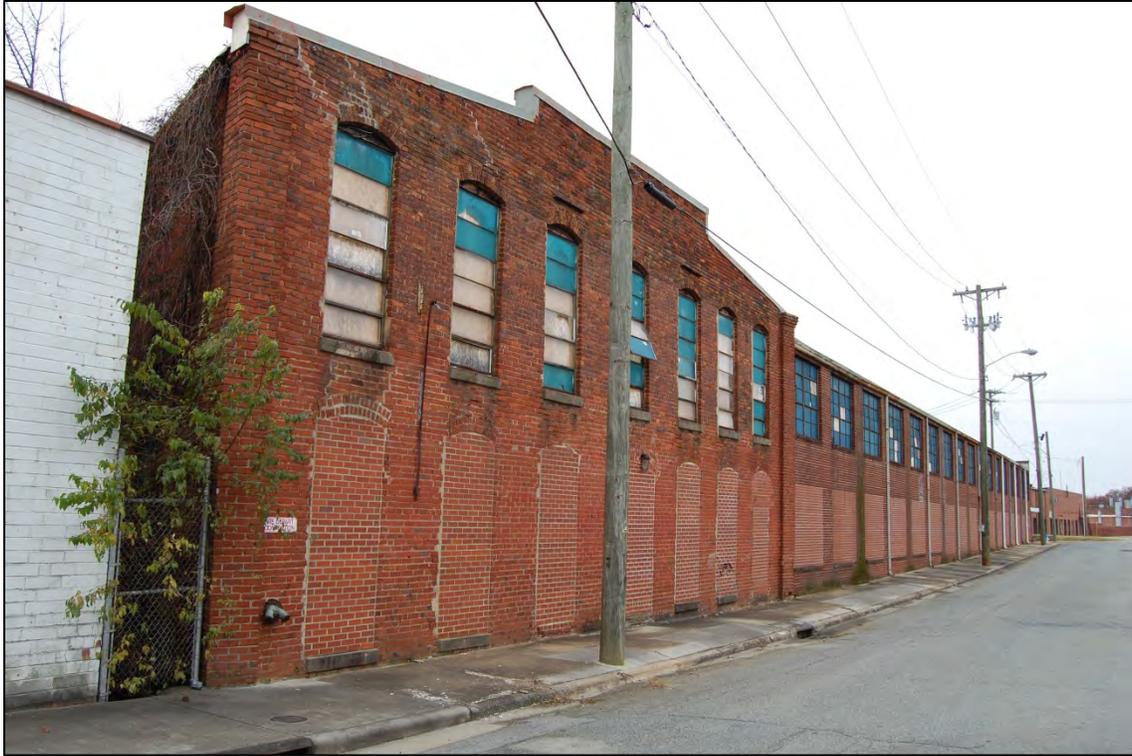
Figure 94: Siceloff Manufacturing Company, north front (Pugh Street) elevation of original factory building at left and ca.1946-1948 addition at right

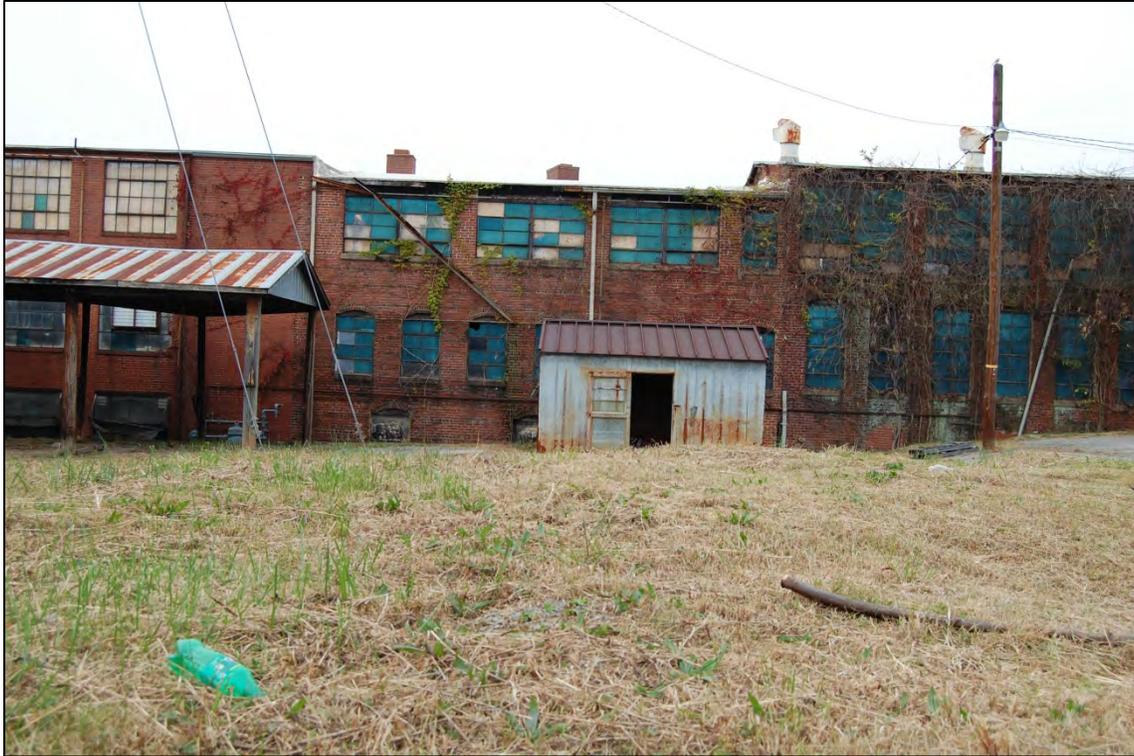
Figure 96: Siceloff Manufacturing Company, east side elevations of 1915 factory with altered bays and sash at right; ca.1923-1929 addition with intact segmental arches at first story and altered second-story bays and sash at center; and 1939 addition at left

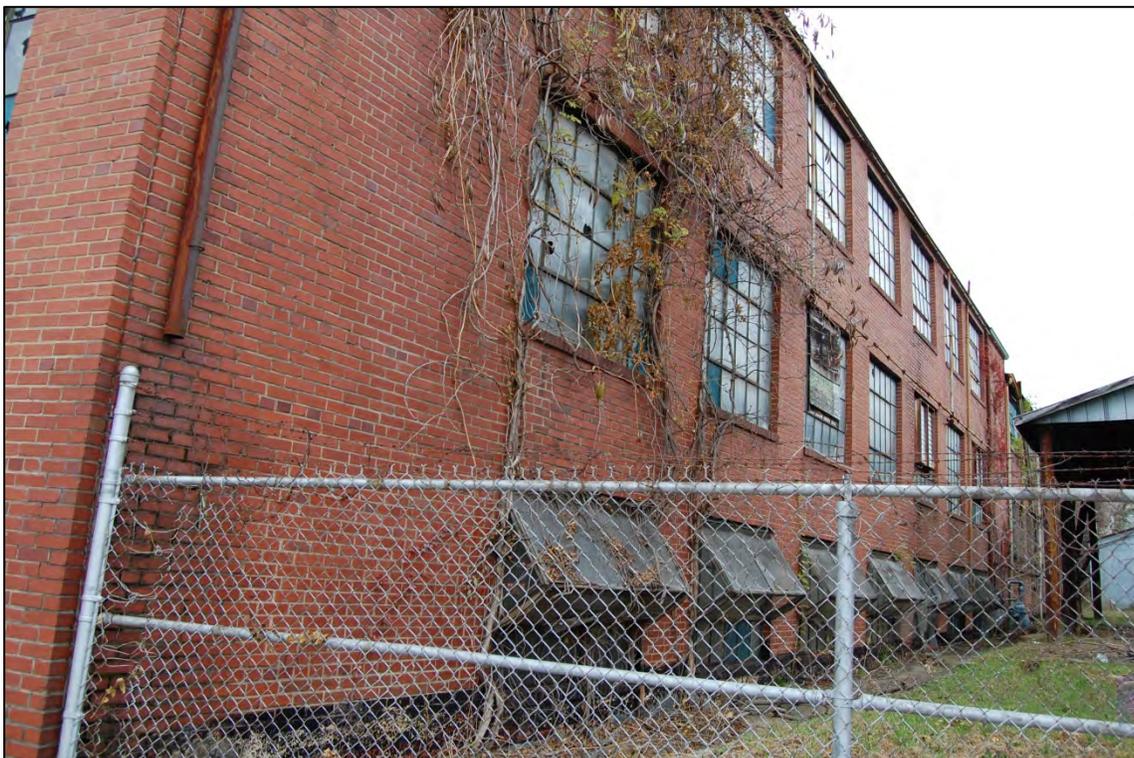
Figure 97: Siceloff Manufacturing Company, east elevation of 1939 addition from Railroad Street

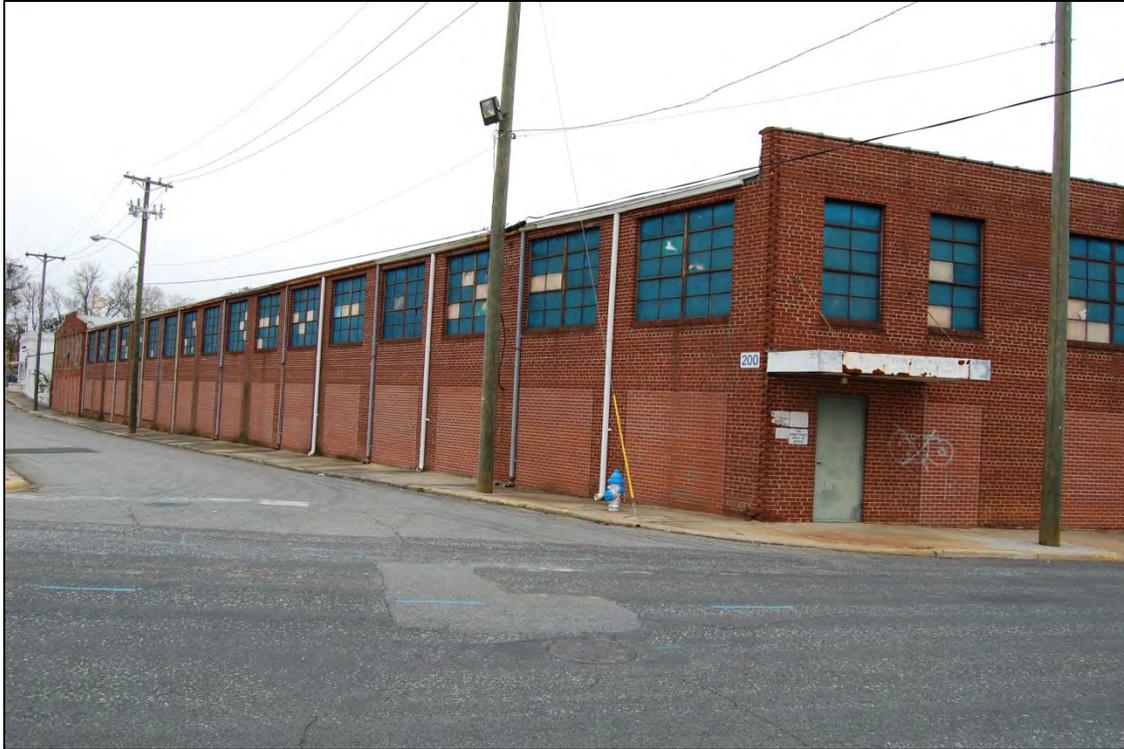
Figure 98: Siceloff Manufacturing Company, ca.1946-1948 addition with north (Pugh Street) elevation at left and west (2nd Avenue) elevation at right

In 1939 an additional two-story-and-basement brick ell was added to the rear of the 1920s addition, extending the factory clear through from Pugh to Railroad Street (Figure 98 and Figure 101 - Figure 103). It was served by large casement windows that remain in place, but for the basement bays on the south rear elevation, which have been bricked over. When the addition went up, some of the bays on at least the west side elevation of the original factory were replaced with similar casement windows. Subsequently all bays of the east side elevation of the original factory were similarly altered, as were the second-story bays of the 1920s addition on the east elevation. Additionally, the clerestory was removed and all sash was updated. Therefore, the only intact components of the original factory and 1920s addition are their walls and the segmental arches of the front elevation of the original building and the east side second-story elevation of the addition. Between 1946 and 1948, after the taking of the historic photograph, the factory was extended by a long two-story-and-basement wing on Pugh Street that reached all the way to 2nd Avenue (Figure 98 and Figure 99). Its finish matches that of the 1939 addition; it is a straightforward industrial building served by large casement windows. These windows remain intact at the second story, but have been bricked over at the first story of the north and west elevations. By ca.1948, therefore, the factory complex was essentially L-shaped with its hinge located at the original building.

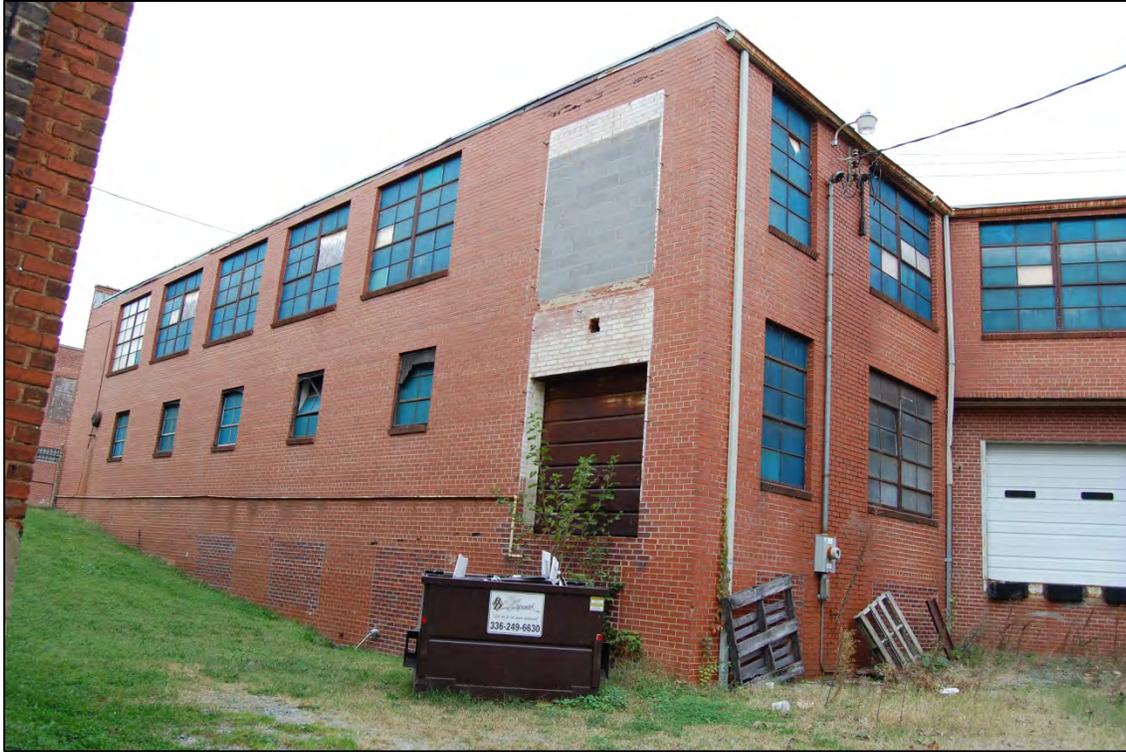
Figure 100: Siceloff Manufacturing Company, ca.1954 additions; note that section with concrete-block infill once connected with Eureka Trouser Company building, the corner of which is visible at far left

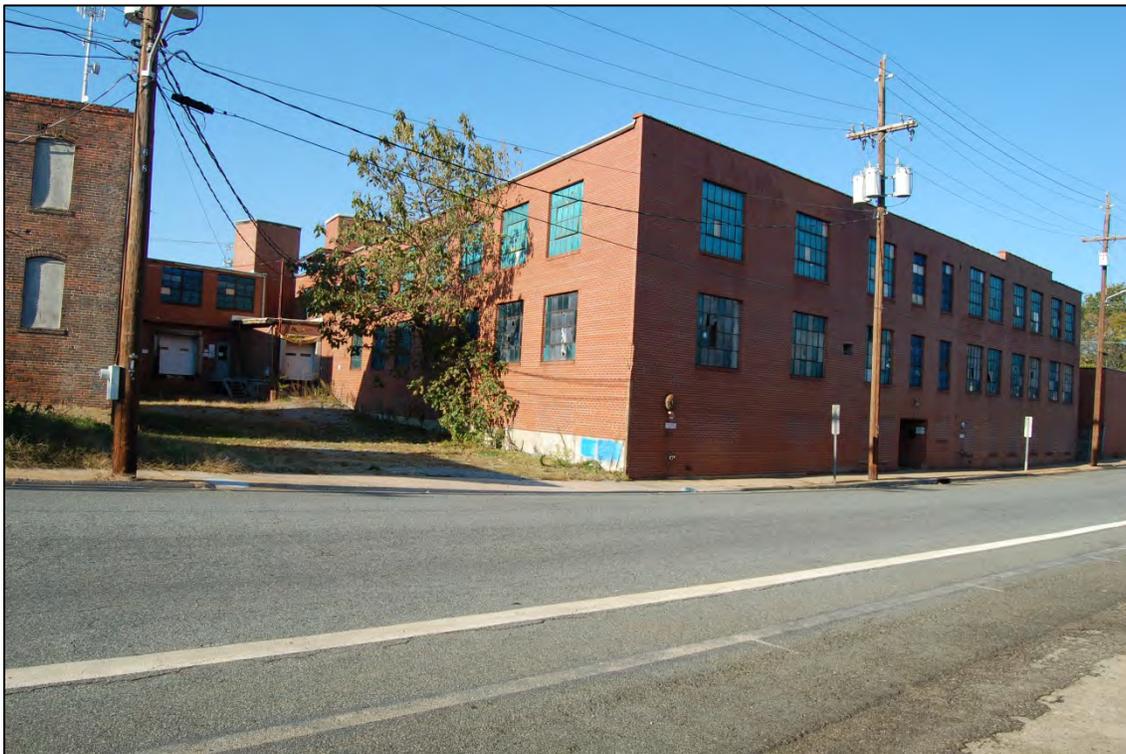
Figure 101: Siceloff Manufacturing Company from Railroad Street with ca.1954 additions at center, 1939 block at far right at parapet roof, and Eureka Trouser Company building at far left

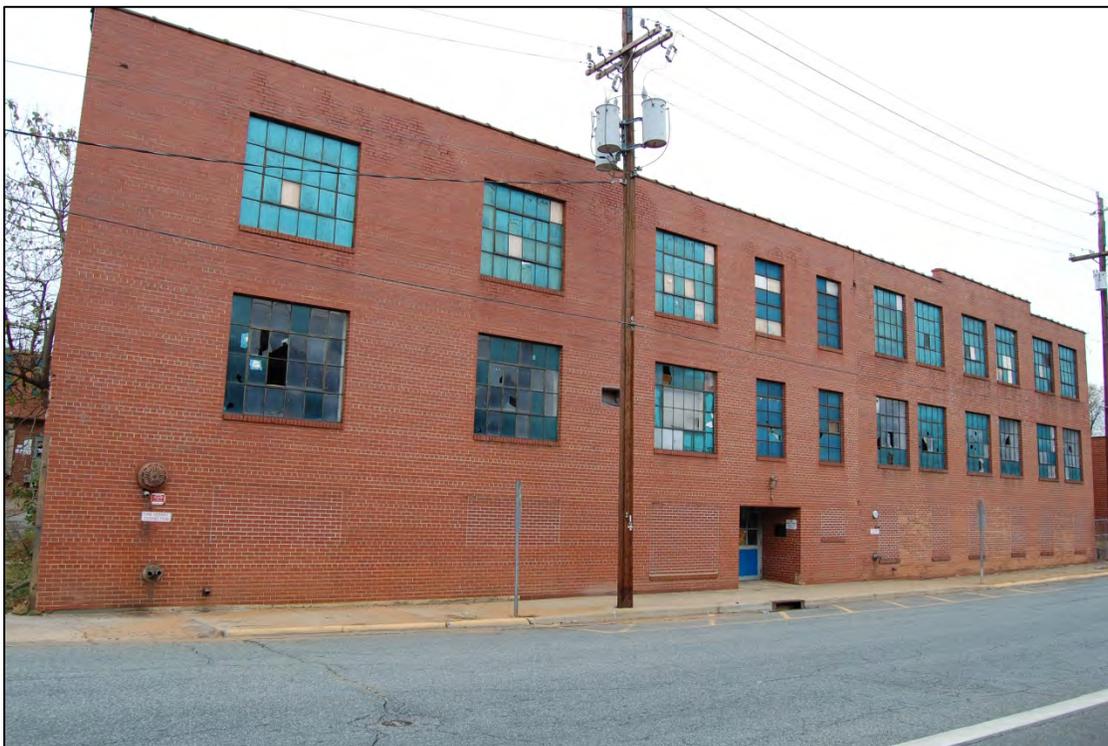
Figure 103: Sicheloff Manufacturing Company, south (Railroad Street) elevations of ca.1954 addition at left and 1939 addition at right

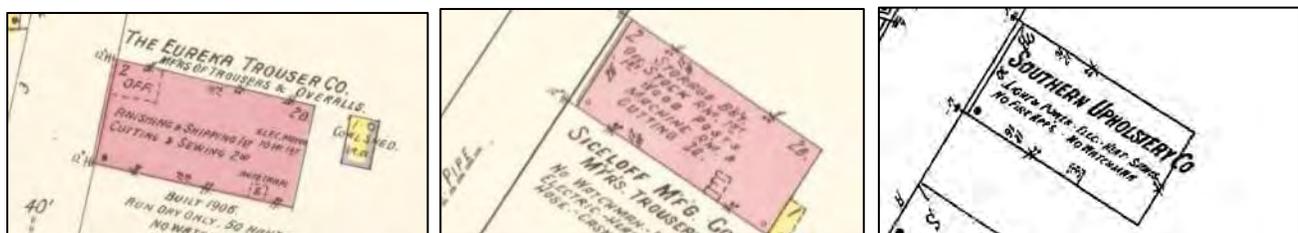
Figure 106: Factory under three different names, Eureka on 1907 Sanborn map at left, Sicheloff on 1913 Sanborn in center, and Southern Upholstery on 1923 Sanborn at right

In 1907, according to the Sanborn map, the plant operated only during the day and employed 50 hands. Cutting and sewing was done on the second floor, finishing and shipping on the first. Electricity for its power and incandescent lights came from the municipal light and power plant, as did its steam heat. In 1909 the company had to shut its plant “on account of delayed freight” (*Men’s Wear* May 8, 1907:83). That fall, after Eureka had already suspended business, it was acquired by D.S. Sicheloff, who had been its bookkeeper. He took over the building and part of its machinery and operated a pants factory there until 1915, when he built a new factory next door (Leonard 1927:339) (see previous entry). The Southern Upholstery Company moved into the old Eureka factory sometime between 1916-1917, when a city directory places its business on North Main Street, and 1923, when the Sanborn map locates it in the former Eureka/Sicheloff building. The 1923 and 1929 Sanborns picture the building, with the same footprint as 1907, as home to Southern Upholstery. The company apparently went out of business during the Great Depression. It is not included in the 1937 city directory: in that year the building functioned as a Dixie Furniture Company warehouse. In a rare turnaround, Dixie—which ultimately acquired numerous factory buildings as part of its expansion in the area—did not retain the building. The 1941-1942 city directory lists the factory as the home of Printcraft and the 1948 updated Sanborn map identifies it not as a printing company, but as a food manufactory, although still with the same footprint. By 1959-1960 the Sicheloff Manufacturing Company was using the building, again, as part of its manufacturing complex. It did so at least through the compilation of the 1970 city directory. By 1980 the building was empty and it remains vacant at present.

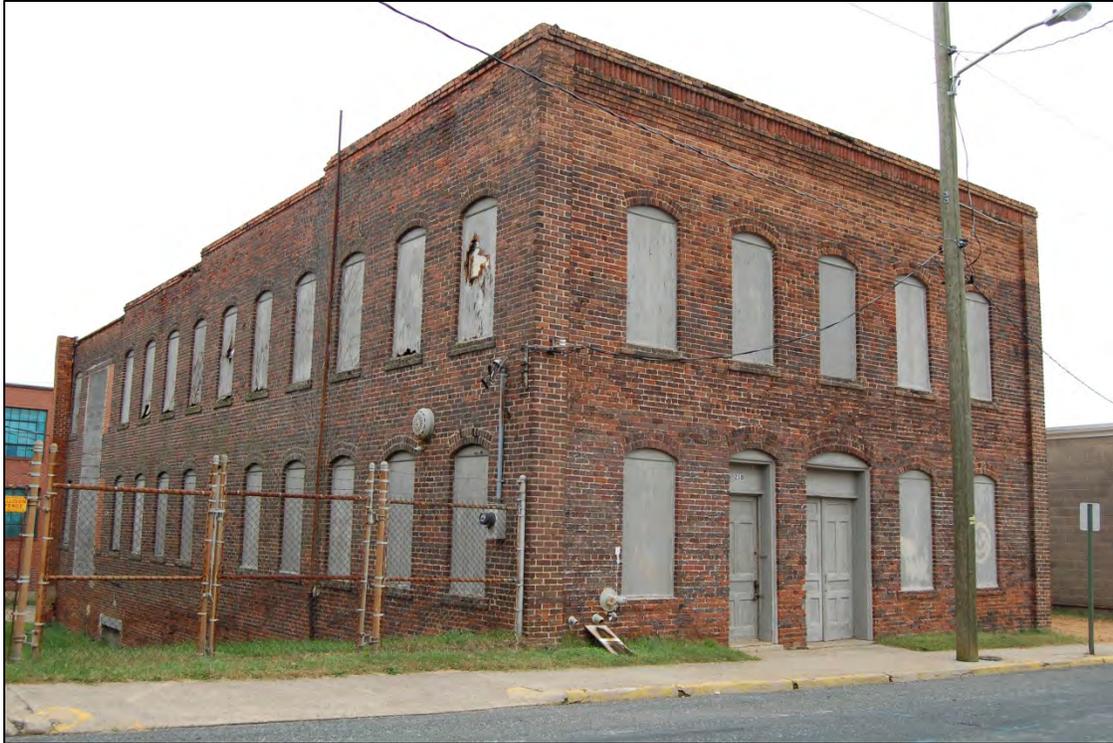
Figure 108: Eureka Trouser Company, west front and north side elevations

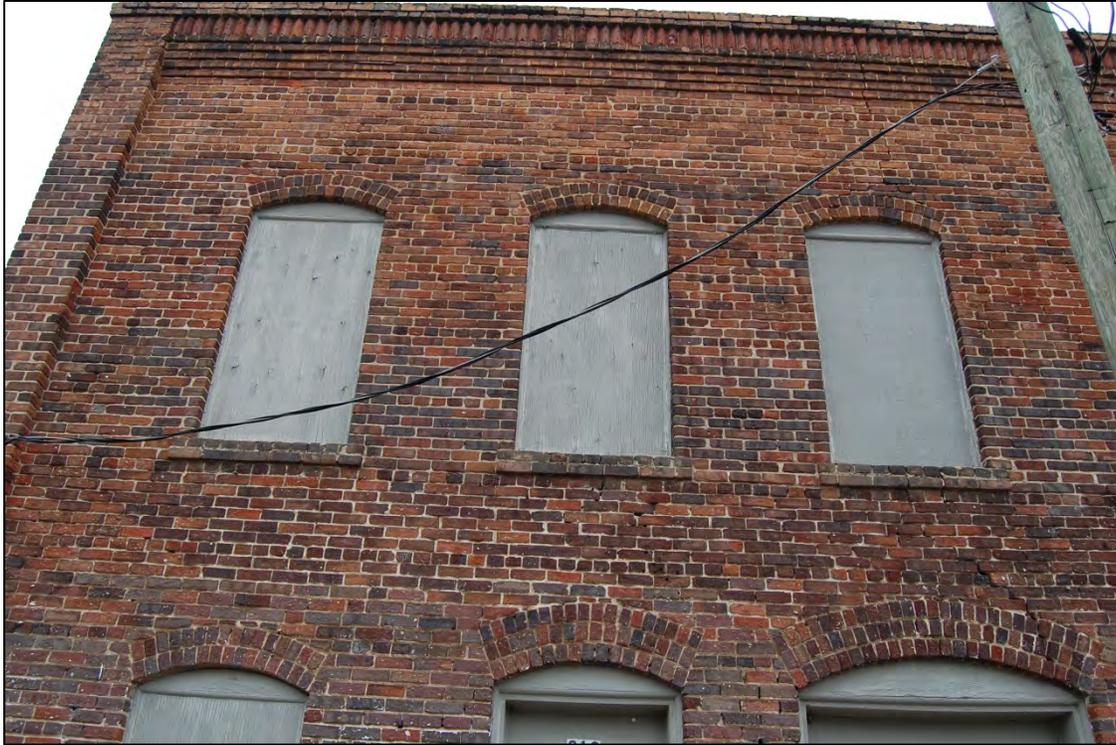
Figure 110: Eureka Trouser Company, west front elevation detail

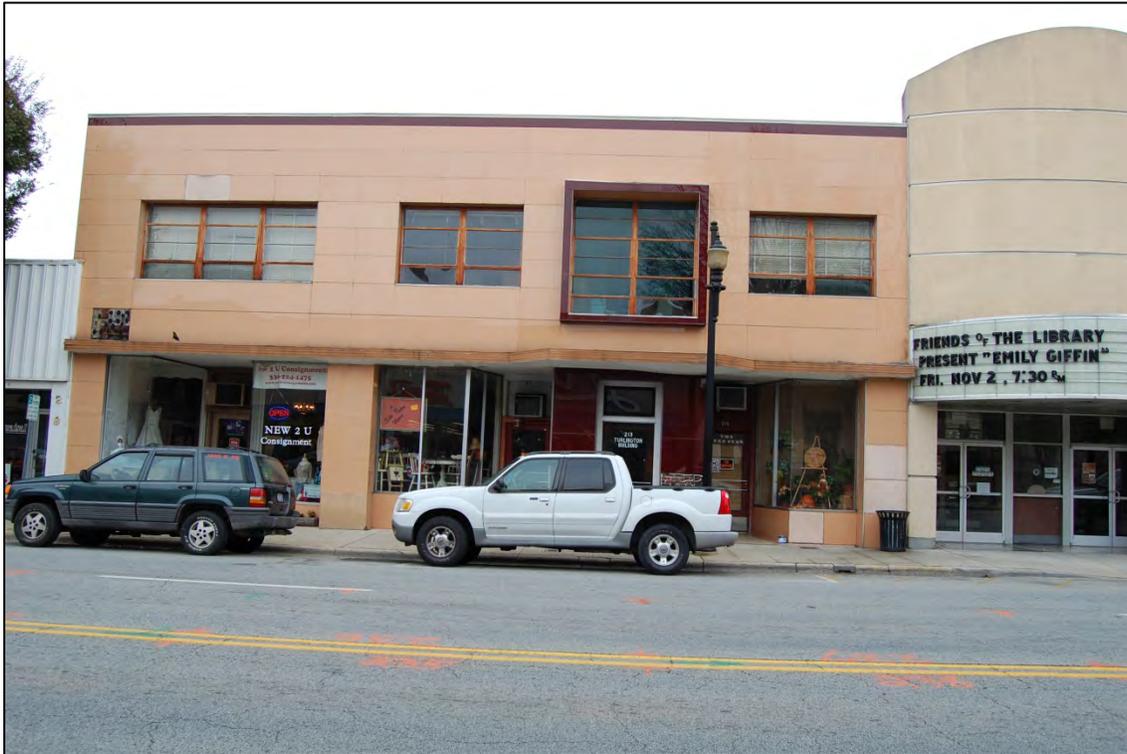
Figure 130: South front (Main Street) elevation of Hedrick Block

The Hedrick Block (DV-584), built in 1947, is an unusual local example of the Art Moderne style clad in Carrara structural glass panels (Figure 130). It is recommended as individually eligible for National Register listing. More information on it and additional images can be found below at its individual entry (URS survey #18A). Also as discussed below, the building is additionally recommended as a contributing part of an addition to the Uptown Lexington Historic District.
